Figure 3 'Loss of SSI application ditches to runway construction'

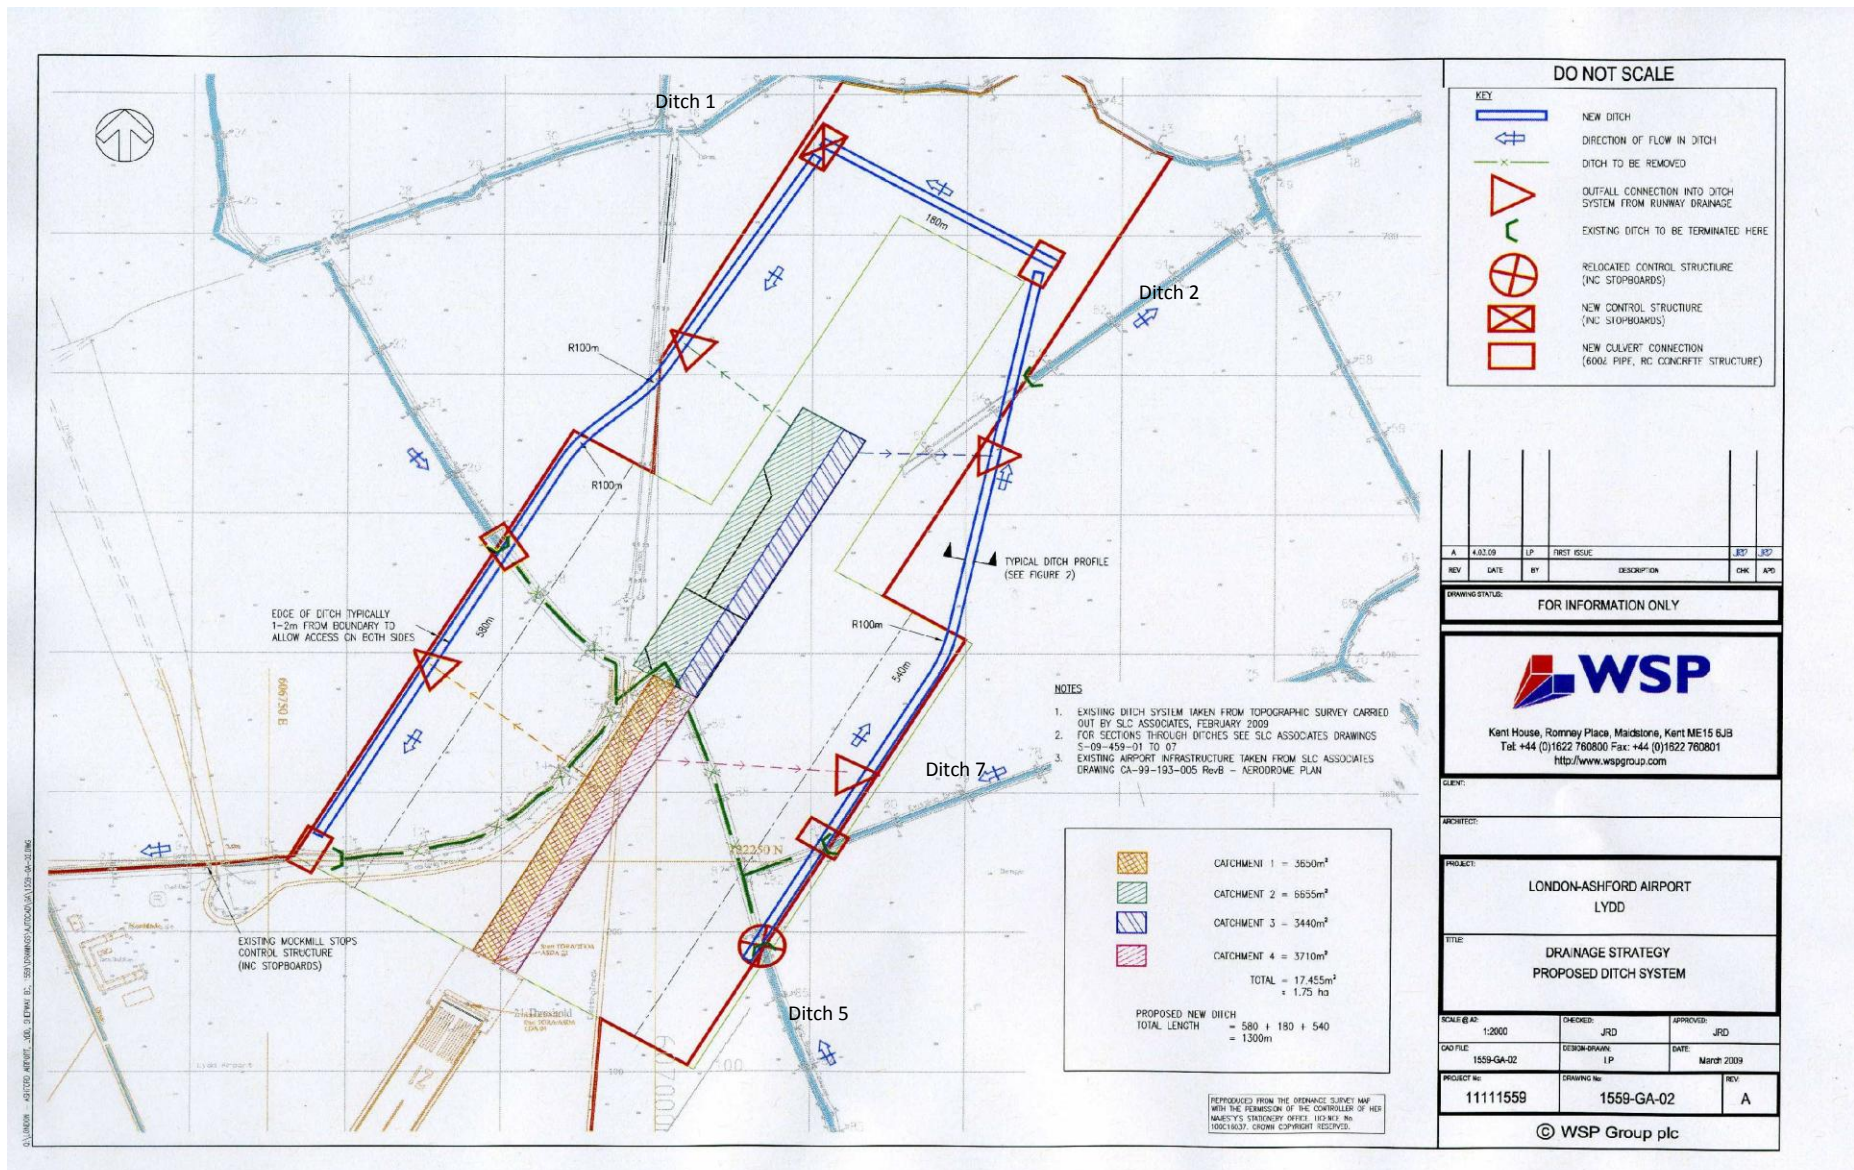
Note: Ditch numbering follows that described by applicant's invertebrate survey (CD1.33a). Other information is from applicant's surface water drainage strategy (CD1.42a). There is some uncertainty over ditch numbering as applicant's invertebrate survey did not provide a map and locations have been inferred from the grid references provided, some of which were missing a digit.
